## **SERVICE BULLETIN**

**Broadcast Division**

MW-1/MW-1A

AM-120-LAP ECN 23812 7/7/78

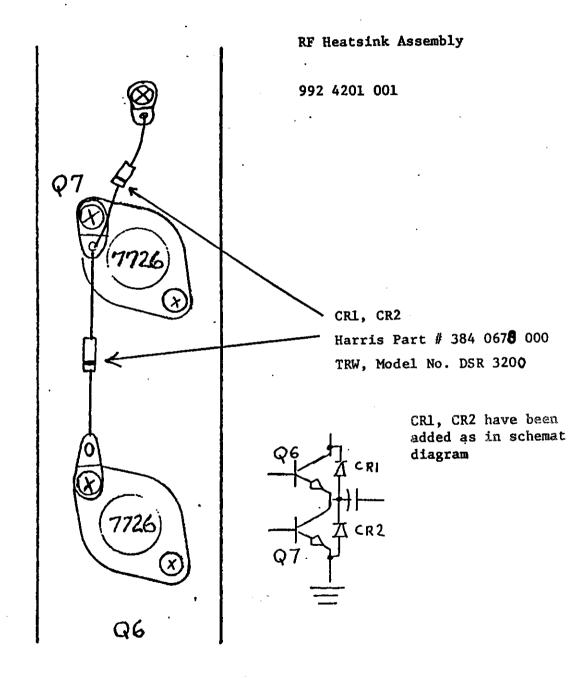
PROBLEMS ENCOUNTERED: Ringing of class 'D' waveform, random and premature loss of Q6 and Q7 in A-1 through A-13 PA module assemblies (992-4201-001), assymetrical PA voltage dip while tuning the transmitter.

The major supplier of these 2N6340 transistors (Motorola) has changed the doping mixture used to manufacture the collector-emitter junction's structure. Thus, the newly created junction characteristics may cause the operational duty cycle to be unstable.

1CR-1 and 1CR-2 (25 nanosecond reverse recovery time diodes) have been added across the emitter collector of Q6 and Q7; A-1 through A-13.

Place solder lugs under transistor mounting screws as shown in attached drawing. Cut both 1CR-1 and 1CR-2 diode leads approximately the same length. Dress leads carefully, making sure they don't come in direct contact with other components. Be sure to heat sink carefully the diode leads when soldering.
